Cherry
Valley Dam (NDI-PA-508, DER-63-56),
Ohio River Basin, Raccoon Creek, Washing-
ton County, Pennsylvania. Phase I Ins-
pection Report.

PHASE I REPORT
NATIONAL DAM INSPECTION PROGRAM

NAME OF DAM: Cherry Valley Dam
STATE LOCATED: Pennsylvania
COUNTY LOCATED: Washington
STREAM: Raccoon Creek, a tributary of the Ohio River
DATE OF INSPECTION: December 4 and 21, 1978

PHASE I REPORT
NATIONAL DAM INSPECTION PROGRAM
CHERRY VALLEY DAM
NDI I.D. NO. PA-508
DER I.D. NO. 63-56

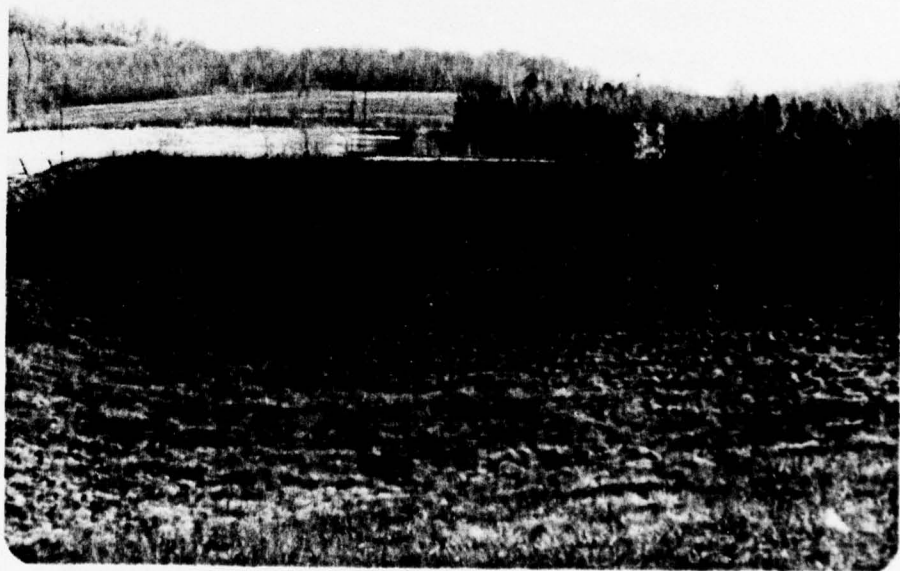
Downstream Face

In general, the condition of the dam is considered to be good. There are patches of brush and several trees up to 10 feet high on the middle one-third of the embankment on the downstream face.

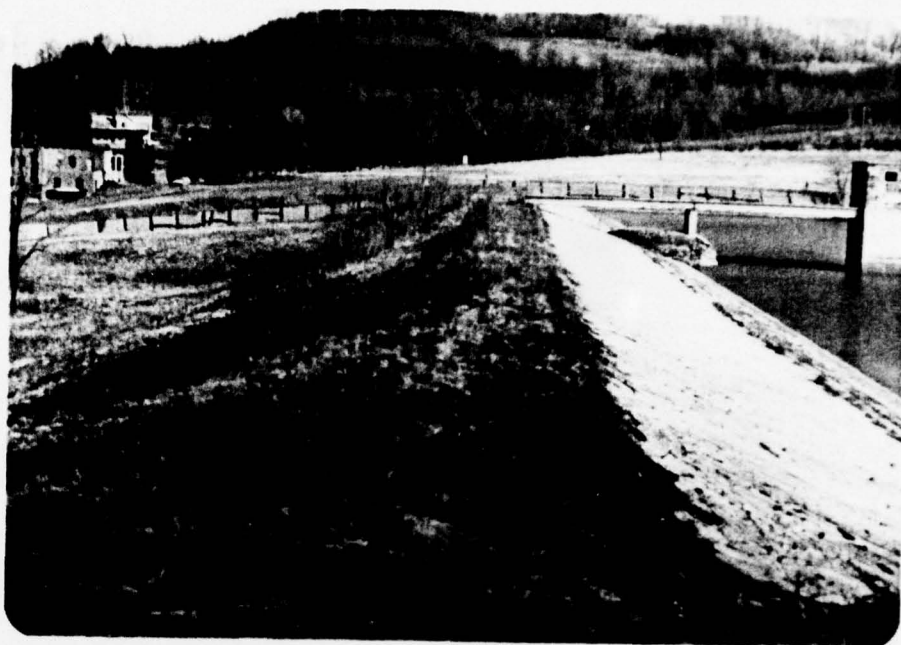
Photograph No. 1
Crest (looking west).

The top of the dam was surveyed relative to the spillway crest elevation and was found to have some vertical irregularities. While the design freeboard of the dam was 7.5 feet, the survey indicated freeboards ranging from 7.2 feet to 7.6 feet. The lowest area occurred approximately 150 feet from the left abutment.

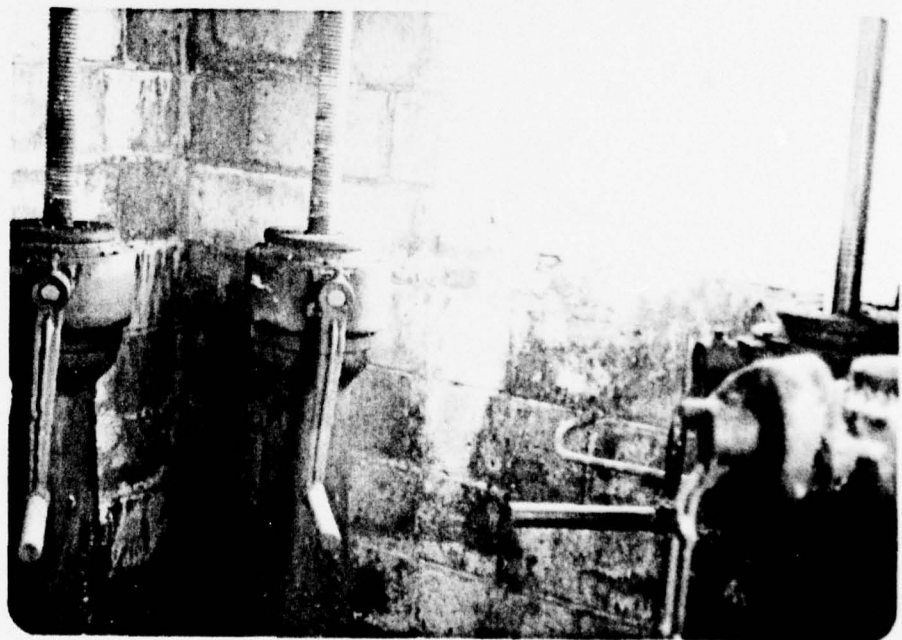
Photograph No. 6
Gate controls at intake tower.

4.3 Maintenance of Operating Facilities. The maintenance of the operating facilities is considered to be poor. Reportedly, the outlet valve has never been operated since construction of the dam. The operation of the outlet valve was not observed during this inspection.

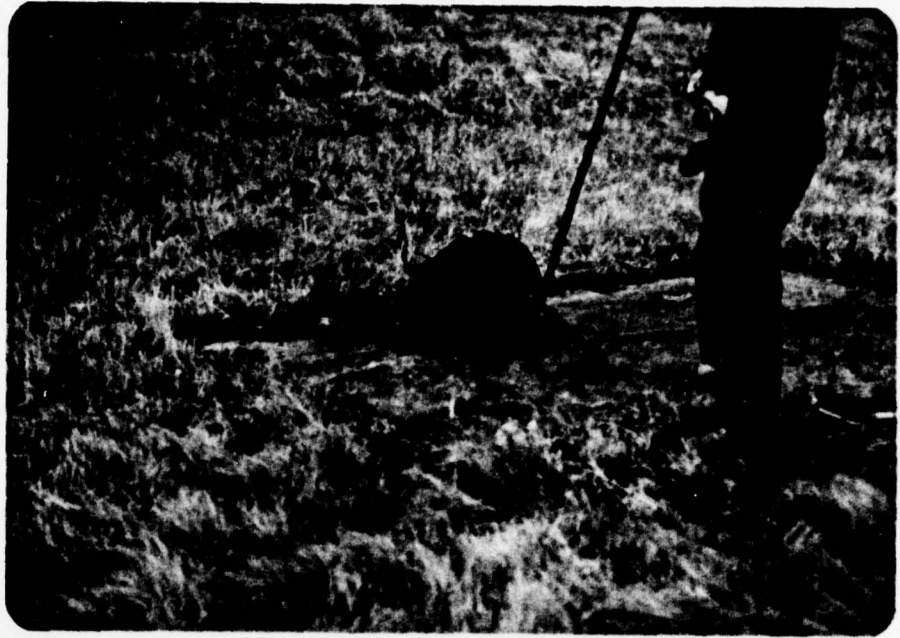
Photograph No. 7

The outlet valve chamber was inspected and found to be full of water. The downstream end of the outlet pipe was below the surface of a pond formed by a dike across the outlet channel and was not visible.

Blow-off pipe valve chamber (at downstream toe of dam).

1. The operational condition of the outlet valve should be evaluated and necessary maintenance performed, if necessary.
2. Adequate drainage should be provided to drain the pond in the outlet works discharge channel. The water in the valve chamber should also be drained and these areas should be inspected for signs of seepage.
3. Brush and trees on the downstream face of the dam should be removed.
4. The crest of the dam should be surveyed and low spots should be filled to design elevation.
5. Around-the-clock surveillance should be provided during unusually heavy runoff and a formal warning system should be developed to
